## Section Inspection - 17/02/2023 - MH4702X

Town or Village:	Clinterty	Inspection Direction:	Downstream	Upstream Node:	MH4702
Road:	Travellers Site	Inspected Length:	16.76 m	Upstream Pipe Depth:	
Location:		Total Length:	17.16 m	Downstream Node:	MH4701
Surface Type:		Joint Length:	1.20 m	Downstream Pipe Depth:	
Use:	Foul	Pipe Shape:	Circular		
Type of Pipe:	Gravity drain/sewer	Dia/Height:	150 mm		
Flow Control:	No flow control	Material:	Vitrified clay		
Year Constructed:	Not Specified	Lining Type:	No Lining		
Inspection Purpose:	Routine inspection	Lining Material:	No Lining		
Comments:	Medium defect				
Recommendations:

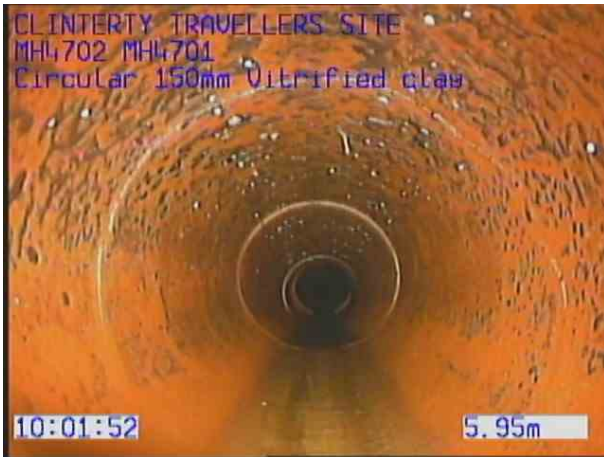
MH4702X\_327954b5-d448-4682-b75a-2287ab7150c3\_20230220\_213106\_968.jpg, 00:02:22, 5.95 m  
Crack, circumferential from 8 o'clock to 4 o'clock

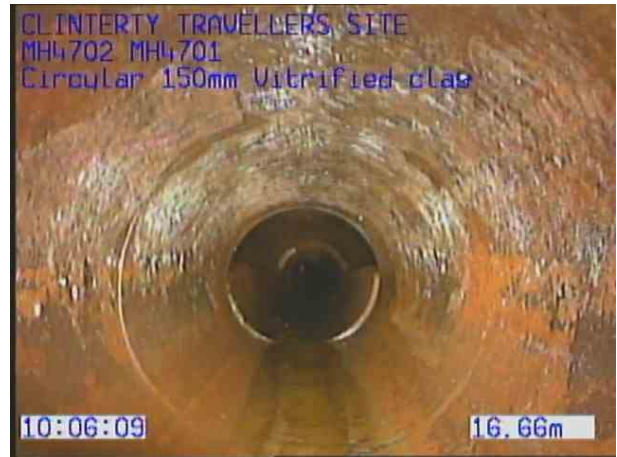
MH4702X\_746f3fc1-433b-49d8-96be-4cddc50edb31\_20230220\_213221\_512.jpg, 00:06:19, 16.66 m  
Fracture, circumferential from 12 o'clock to 12 o'clock
